Alaris® System IUI inspection

IUI inspection

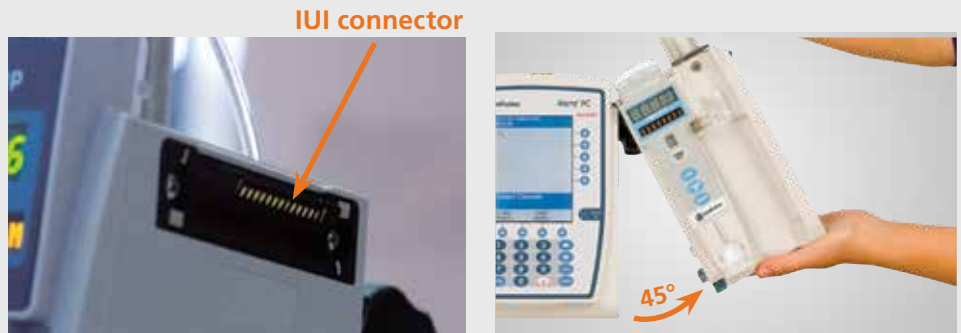
If any surface contaminants, or blue or green deposits are visible, this means the connector requires replacement.
